# Preliminary report on the geological effects triggered by the 2014 Cephalonia earthquakes

**Papathanassiou G., Ganas A., Valkaniotis S.,  
Papanikolaou M., Pavlides S.**

**INSTITUTE OF GEODYNAMICS**  
NATIONAL OBSERVATORY OF ATHENS

**February 2014**

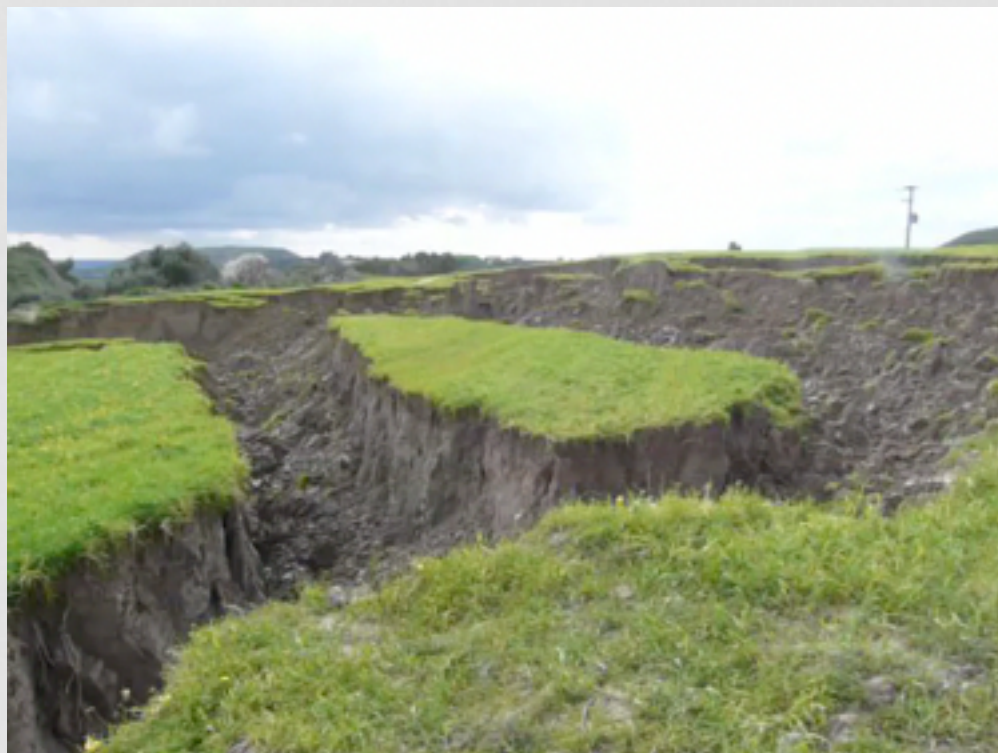
Figure 3. Large-scale landslide in the area of Soullari (photo taken on 8/02/2014, view to the south)

Landslides of small/medium size were widespread in soft Neogene and Quaternary sediments, but also locally observed in clastic formations of Miocene flysch deposits. One of the most impressive mass movement phenomena was the Soullari large landslide, situated north from the Soullari (Fig. 3) village in Palliki peninsula. The landslide was activated during the first earthquake (Jan 26, 2014) on homogenous silt/clay Pliocene-Pleistocene sediments, in a small field on top of a hill and it was re-activated after the second event (Feb 3, 2014). The re-activation was most probably assisted by the presence of rain water in the week following the first earthquake, and caused further movement of the block down-hill, along with a break of the block piece in two smaller ones and collapse of the surrounding scar-walls.

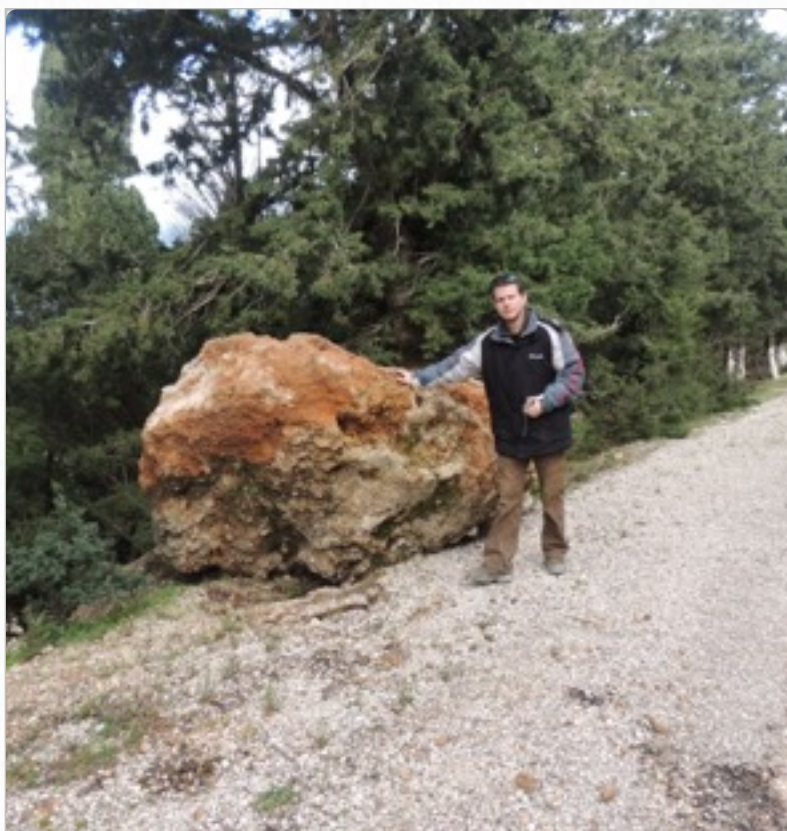
Figure 4. Rock falls (photo taken on 29/01/2014)

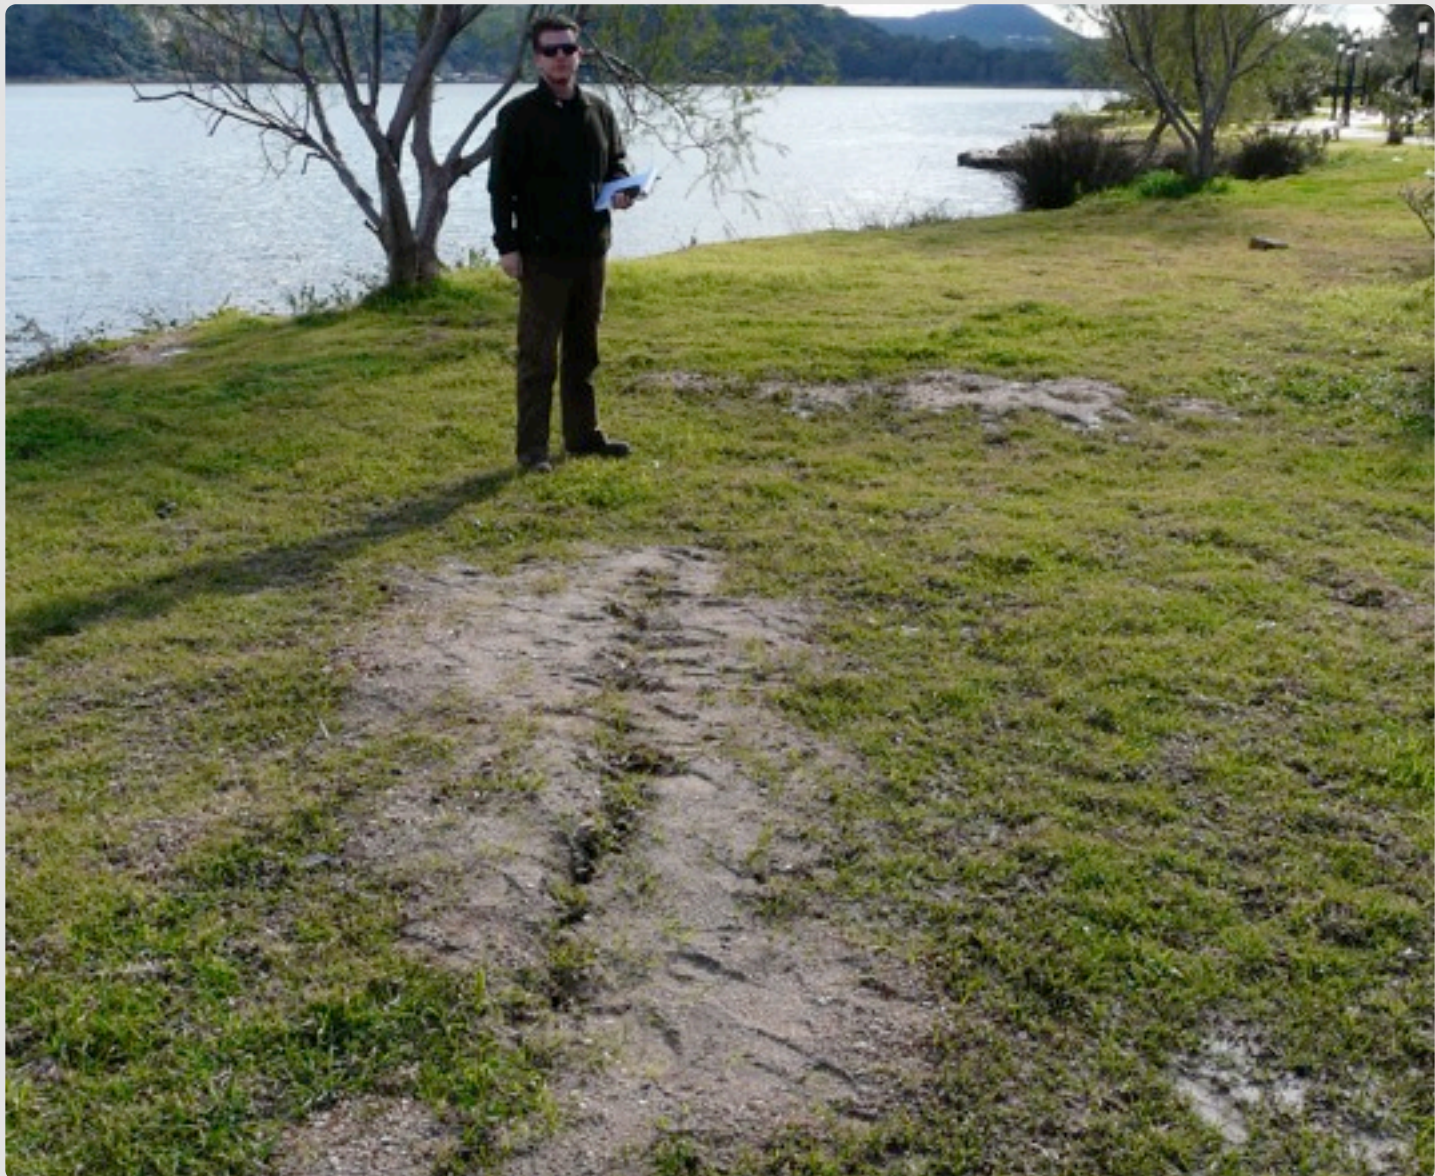
In the town of Argostoli, clear evidences of liquefaction occurrences like sand boils and ground fissures with ejection of silty sand-water mixture (Fig. 6), have been triggered by the first and second event according to eyewitnesses and mapped by our team during the post-earthquake field surveys. These liquefaction phenomena were observed in the quays of the town inducing small-scale structural damages. However, it should be pointed out that typical lateral spreading phenomena were not observed at the broader area of the gulf of Argostoli.

Figure 6. Liquefaction phenomena in the waterfront area in Argostoli (photo taken on 8/02/2014)

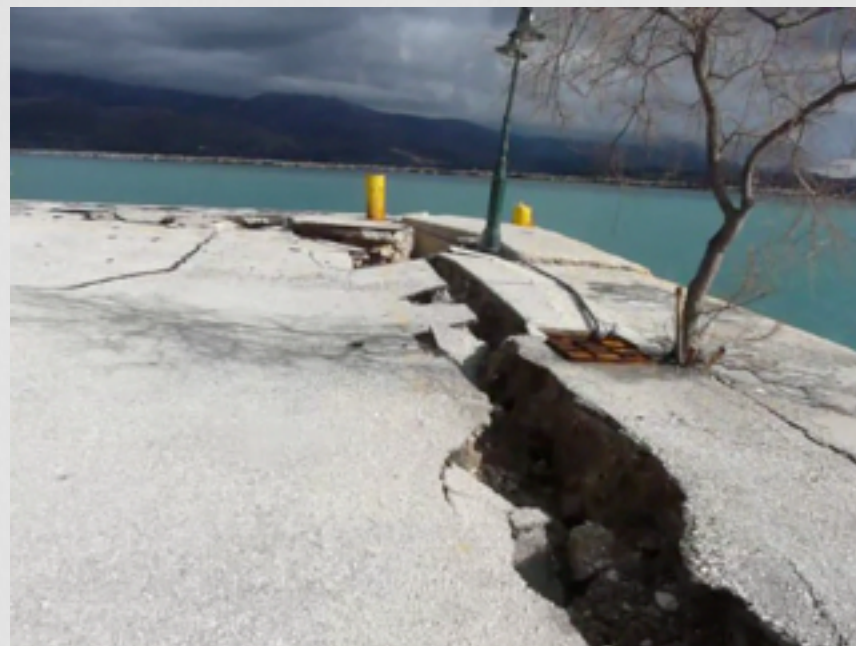
In the waterfront area of Lixouri, the liquefaction of the subsoil layers induced severe damages to port facilities and caused the complete loss of functionality for 24 hours. In particular, quay wall displacement toward the sea, opening of cracks and significant vertical and horizontal displacement of the sidewalk in the backyard of the quay wall and lateral spread of the pavement in a pier were observed and documented (Fig. 7, 8).

Figure 7. Liquefaction-induced damages in the quay in Lixouri (7/02/2014)

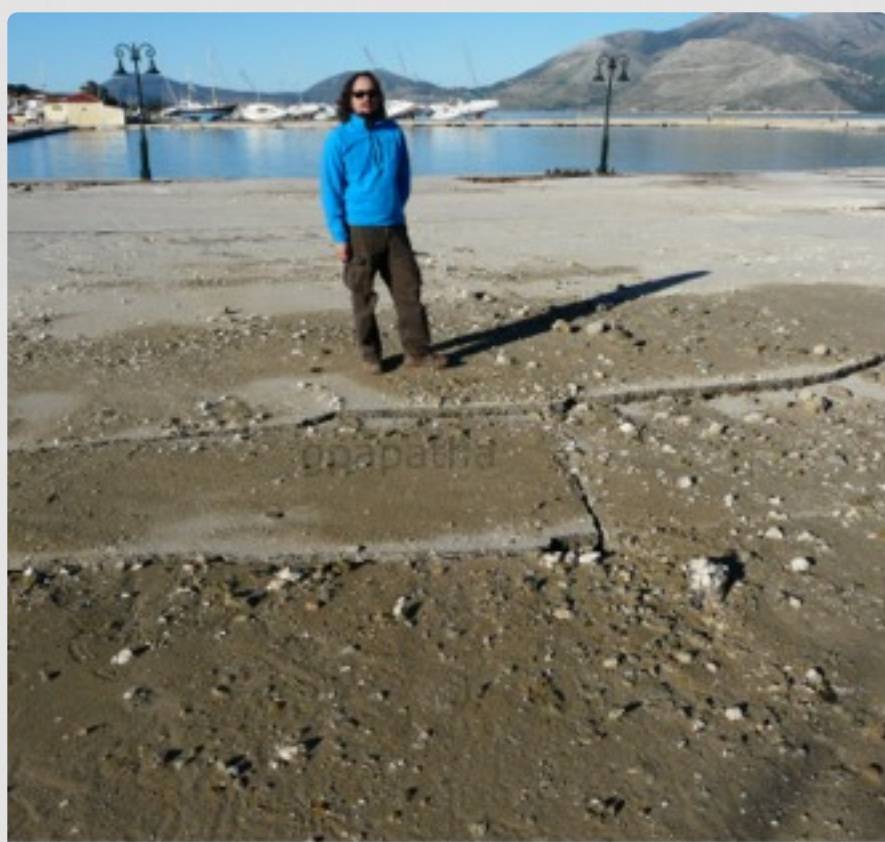
Figure 8. Ejected material in the quay of Lixouri (photo taken on 7/02/2014)
